PUBCO FLUSH VALVE – MAINTENANCE AND SERVICING

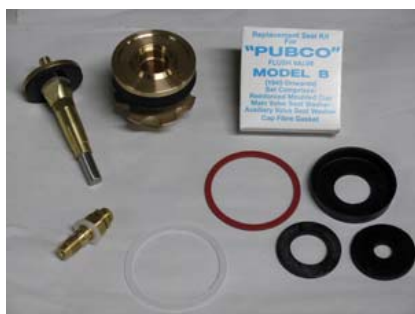
The Pubco flush valve is a simple mechanical flushing device that is designed to withstand high intensity usage. With care and proper maintenance the valve should provide a very long service life.

The valve body and main casting components are made from certified gunmetal or red brass (85 to 88% copper). This provides the best possible life for the body, seats and inner valve components as the nominal zinc content is 5%. In stable waters this should give a service life of 20 to 30 years.

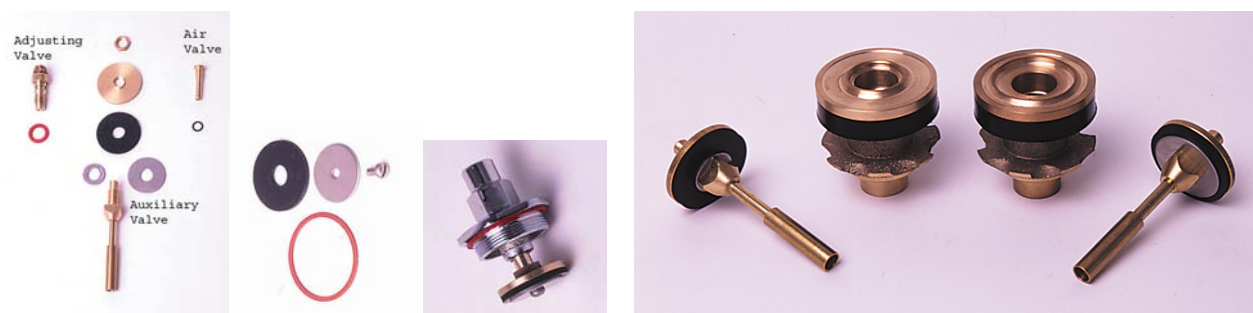
Flush too short or no operation

The bucket washer is worn and allowing rapid by-pass of water into the auxiliary valve chamber.

The auxiliary valve stem is worn or bent and therefore not allowing proper tilt of the auxiliary valve during operation. (evident under higher pressures)

The operating stem is worn or not fully closing against the body handle boss and therefore not allowing proper tilt of the auxiliary valve during operation.

Adjusting valve is worn or not capable of restricting by-pass. (not a common problem.)

Replace the bucket washer.

Replace the auxiliary valve, or replace the auxiliary valve stem and sleeve as a pair.

Replace the operating stem and ensure the auxiliary valve is tilting correctly.

Replace the adjusting valve.

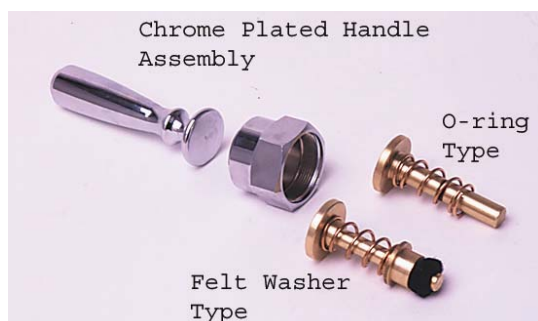
Handle assembly

There are two types of handle assembly.

- O-ring type which is in valves manufactured after 1965 and which requires o-ring lubricant.
- Felt washer and gland type. Lubrication is ordinary grease saturated into the felt.

In both cases inspect the operating stem for excessive end wear and ensure that the springs are fully clamped over the boss on the operating stem and gland in the case of the felt washer type.

It is important that the operating stem is able to travel fully up to and against the body handle boss. This ensures the correct and full tilt of the auxiliary valve and this travel must be checked particularly after replacing the felt washer.

The handle nut should be inspected for wear at the point where the handle is retained by the nut. Wear here will reduce the effective throw of the operating stem.

The operating stem should be inspected for wear at the point where the handle works in a cam like manner. Wear will reduce the effective throw as above and anti-scuffing paste is used here to provide lubrication.
